TIP SHEET

BEWARE OF RECONDITIONED MEDIUM VOLTAGE FUSES

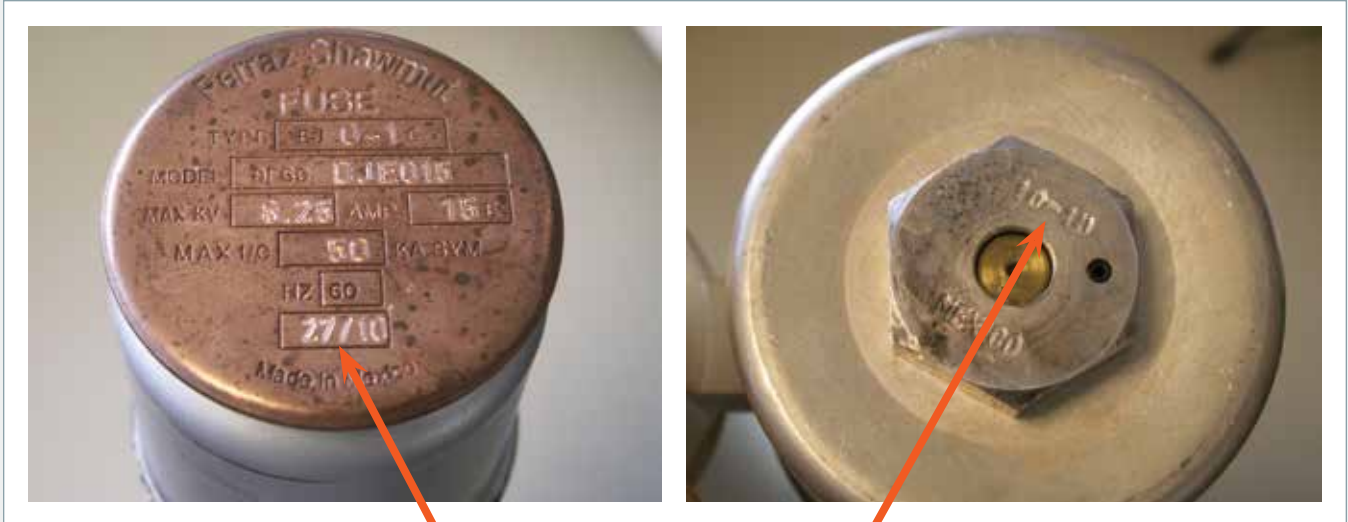
Mersen experienced a more typical situation involving a medium voltage fuse that was manufactured in the 14th week of 1999, indicated by the "14-99" stamped into the metal end. It went

Mersen was aided by the date codes to determine when the fuse was manufactured, as shown in the photo on the reverse side. Brand labels can also be used to determine the approximate date of manufacture. Our brands have migrated from Chase-Shawmut, Gould-Shawmut, GE to Ferraz-Shawmut and now, Mersen. Medium voltage fuse sales are recorded for each authorized distributor. With the date of manufacture, the fuse is traceable through the authorized Mersen sales network.

Always look for the manufacturer's date code!

- 1) When purchasing medium voltage fuses, always use a trusted, authorized distributor.
- 2) Insist on an approval directly from Mersen if the fuse is more than 3 years old.
- 3) If the date stamped on the medium voltage fuse is missing or altered, notify your supplier for a replacement.
